Mw 6.4 Petrinja earthquake in Croatia: Main earthquake parameters, impact on buildings and recommendation for their structural strengthening

University of Split
Faculty of Civil Engineering, Architecture and Geodesy

Subject review

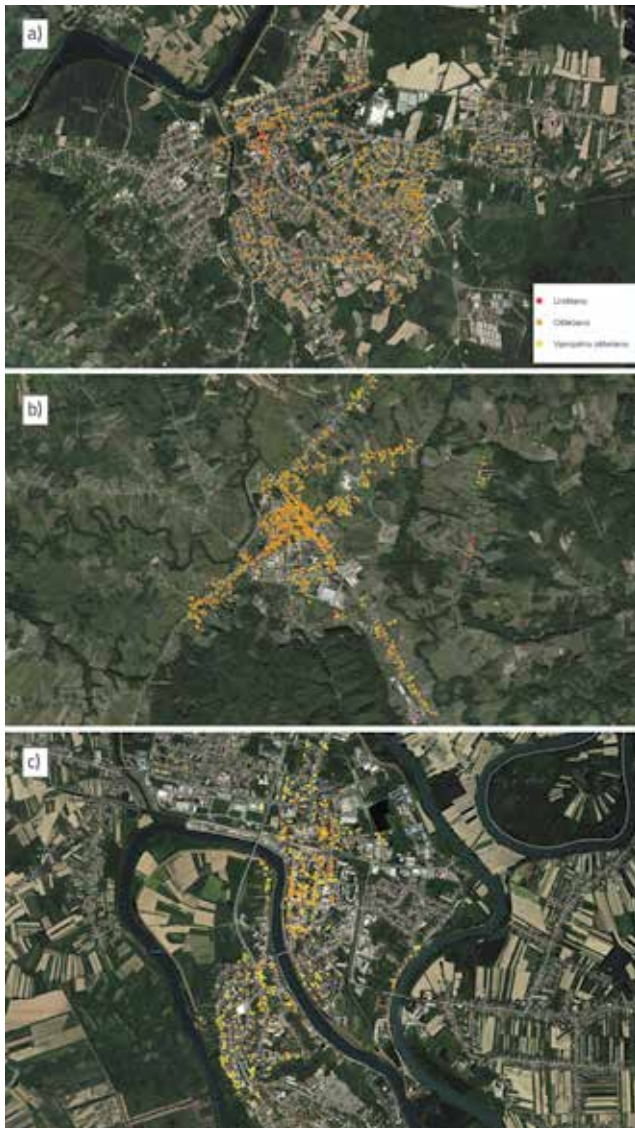
In addition to the loss of seven lives and dozens of injured, thousands of peoples were left homeless. The greatest levels of destruction were registered in the area of Petrinja, Glina and Sisak. Damage to approximately 50,000 buildings has been reported so far. A lot of damage also occurred in the vicinity of Zagreb and Karlovac, as well as in Bosnia and Herzegovina and Slovenia. Figure 17 shows a satellite image of damaged buildings in the area of Petrinja, Glina and Sisak [8]. The actual extent of damage is much greater because the damage inside the buildings, and other damage that could not be registered by satellite, is not included.

Figure 17. Satellite image of damage to buildings in the area of Petrinja, Glina, and Sisak [14]: a) Petrinja; b) Glina; c) Sisak

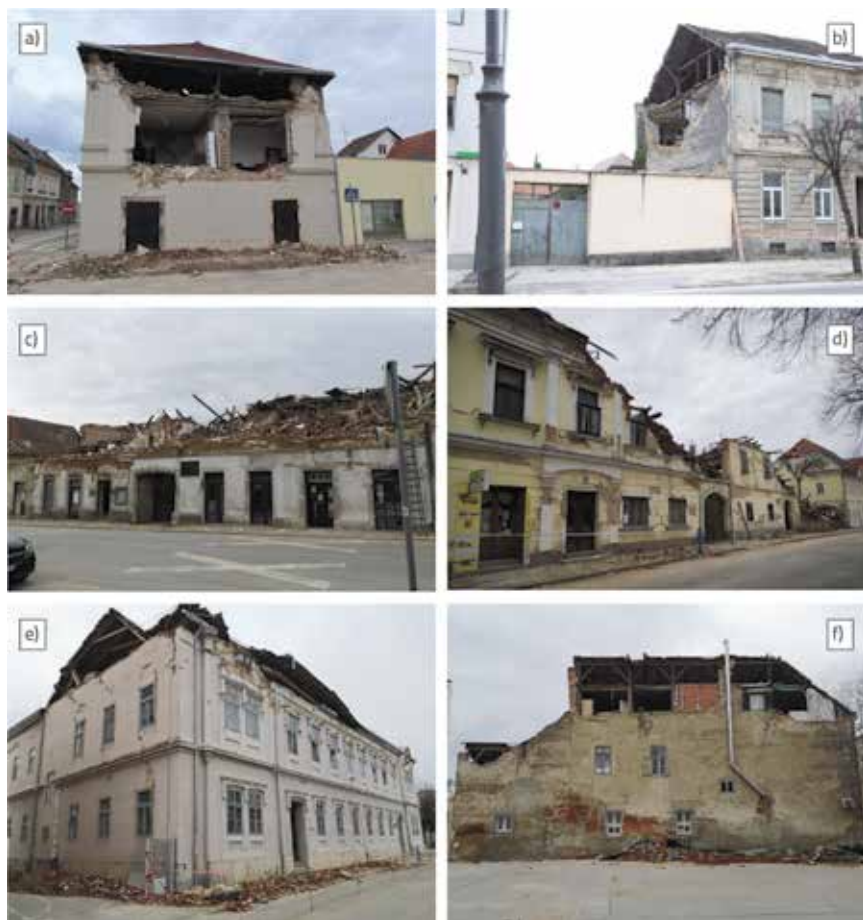
Flexible gable walls and wooden roof structures of many buildings either caved-in or were severely damaged (see some examples in Figure 19). At that, these gable walls were often free-standing and of great height, and the horizontal pressure of rafters for permanent load was often directly transmitted via the wooden overhang laterally to the plane of the facade walls (not to the connecting beams). An

Figure 19. Buildings in Petrinja with severe damage to gable walls and wooden roof

example where an inadequate wooden roof structure caused horizontal lateral displacement of the wall is shown in Figure 19e.

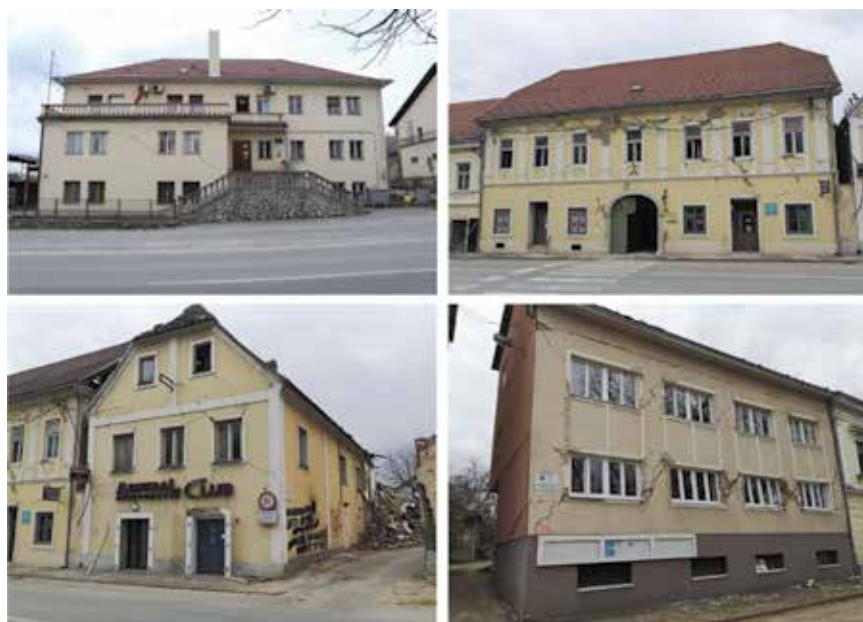
Figure 20. Buildings in Petrinja with typical damage to load-bearing façade walls

Characteristic damage to masonry walls with openings is visible in buildings shown in Figure 20, as well as in some buildings in Figure 19. Typical cross cracks in the columns between the openings in the wall, as well as in lintels, are due to the influence of bending and shear arising from earthquake action, i.e., they are due to the exceedance of principal tensile stresses (especially in the horizontal direction, where compressive stresses are minimal). High vertical seismic acceleration results in: (i) a decrease in vertical compressive stress and exceedance of shear strength of the material when force is opposite to gravity and (ii) an increase in compressive stress and exceedance of compressive strength of the material when force acts in the direction of gravity.

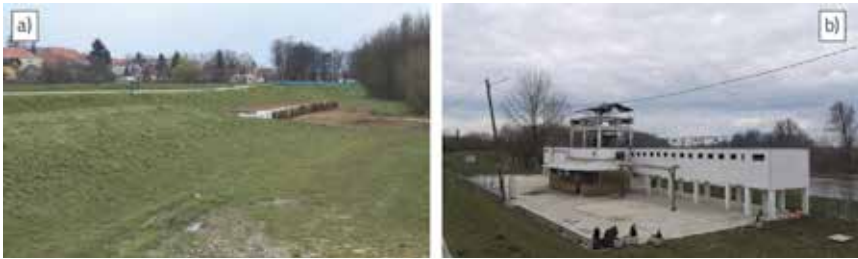
A significant embankment subsidence was registered along the left bank of the river Petrinjčica, near the bathing facility. It is due to the influence of seismic acceleration, especially its vertical component, on the thick layer of saturated soft soil, and to soil liquefaction (Figure 21a). Traces of horizontal displacement of more than 10 cm are visible in the asphalt surfacing on top of the embankment. Such ground displacements are also visible next to a nearby two-storey bathing facility situated along the Kupa River (Figure 21 b), which suffered severe damage (cracks) at the base and on top of reinforced concrete pillars of the first floor. In addition to large seismic forces, the unfavourable flexible structure of the building at the ground floor also contributed to this damage. Traces of eruption of sand on the ground surface due to liquefaction are visible along the bathing facility.

Figure 21. a) Subsidence of earth embankment at the approach to the bathing facility and (b) bathing facility in Petrinja along the Kupa River (b)

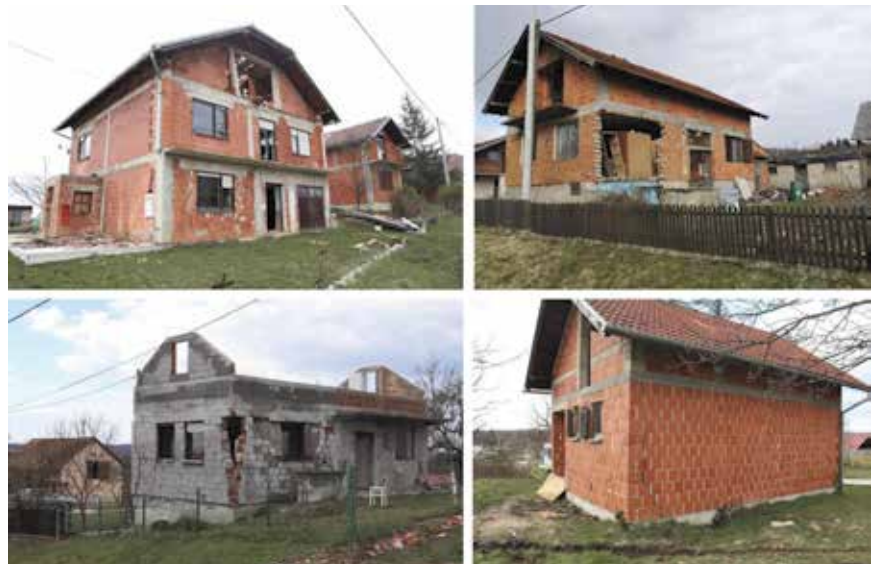
Figure 23. Characteristic damage to family houses in Novo Selo Glinsko

The monuments were also overturned in a SW direction, towards the earthquake epicentre (due to opposite direction of the inertia force of the monuments as related to the acting seismic force). Some characteristic damage to the buildings in this village is shown in Figure 23.

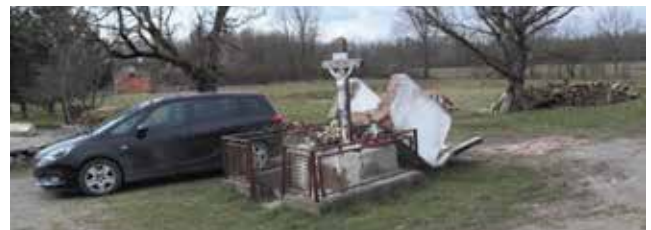
the fact that this village is located on thick layers of soft soil and that the influence of the horizontal component of seismic acceleration was quite significant. Namely, in most of the damaged buildings, the entire walls or their edges were shifted to the SW, i.e. in the direction of the shock wave from the earthquake epicentre. This caused numerous vertical cracks in the walls, resulting from the action of large impact transverse forces. Large seismic forces at this site can clearly be seen in two overturned small stone monuments, whose dimensions in the direction of the overturning was only slightly smaller than their height (Figure 22 shows an overturned chapel).

Figure 22. Overturned chapel in Novo Selo Glinsko

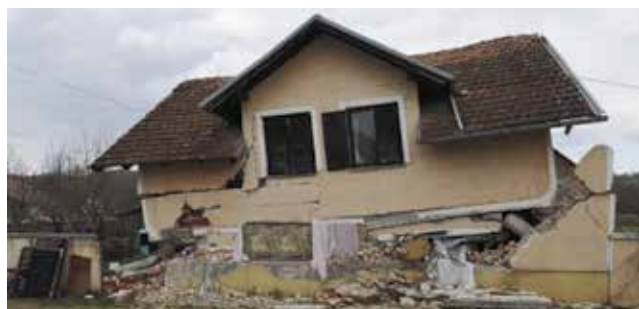
collapse of houses in which human lives were lost. One of the rarer cases of family houses collapsing due to flexibility at the ground floor level can be seen in Figure 25, which shows a two-storey building in the village of Prekopa, located about 9 km SW of the earthquake epicentre, along the Glina - Petrinja road. Due to low stiffness of the ground floor, stronger seismic forces impacted the upper stiffer floor and caused collapse of the elements of the lower floor, with translation of the upper floor by approximately 1.0 - 1.5 m in the SW direction (earthquake impact direction). The large eccentricity of the stiffness centre on the ground floor as related to the mass centre also provoked horizontal rotation of the upper floor (which was damaged, but preserved integrity) in relation to the ground floor plan. Some other factors also contributed to the collapse: poor quality of masonry, lack of tie beams/columns, poor construction, etc.

Figure 25. A family house in Prekopa was demolished due to flexible ground floor and force of the earthquake

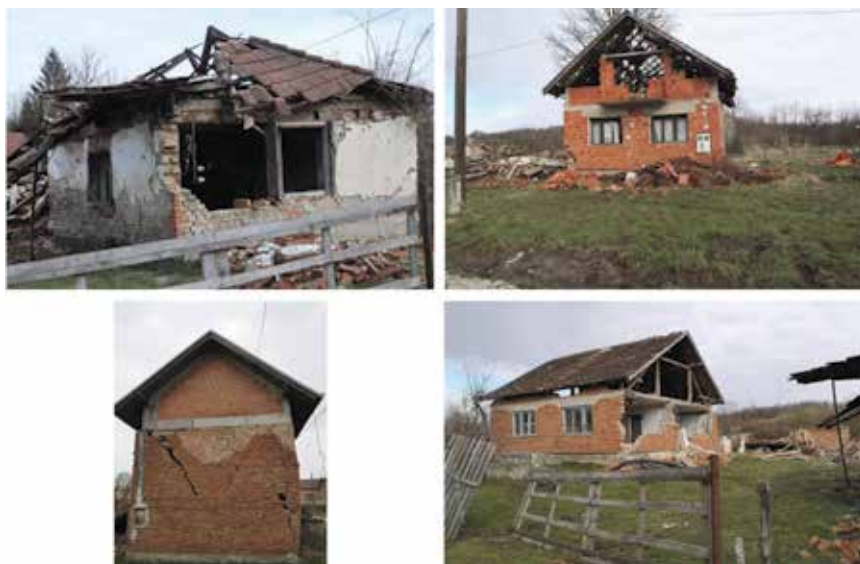
The most severe damage to family houses in the villages around the earthquake epicentre area probably occurred in the village of Majske Poljane, where six people lost their lives. The village is located about 11 km SW of the earthquake epicentre, and it lies on a predominantly flat terrain with possibly thicker deposits of soft water-saturated soil. The strongest damage, but not the greatest seismic forces, is explained by the fact that in this area family houses are of the worst quality, and the load-bearing structures are in many cases improvised only (especially those for farm buildings). Based on such quality of the buildings, it can be concluded that local residents are economically deprived. It is suspected that, in addition to poor structure and inadequate construction, the foundation conditions, and possibly soil liquefaction, also greatly contributed to the

Figure 24. Photos of some severely damaged and demolished houses in Majske Poljane

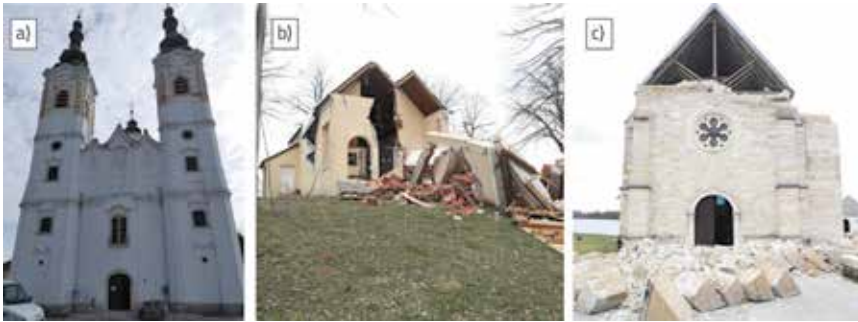
Several churches and other sacral buildings were also severely damaged or destroyed in the area affected by the earthquake. Some of them are shown in Figure 26. Bearing structures of most of them are even weaker than those of the previously described residential houses. In fact, they are usually much higher, more massive, subject to higher seismic forces, characterised by larger spans/measurements and more complex structure and, in some cases, they have larger unfavourable openings.

Figure 26a shows the severely damaged St. Mary Magdalene Church in the village of Sela near Sisak, located about 13 km NE of the earthquake epicentre. The church has numerous vertical cracks in masonry walls due to excessive horizontal tensile stress in a poor-quality brick wall, as well as oblique cracks in columns and lintels along openings due to shear. Numerous cracks were registered in the massive, large-span dome. The mentioned dome generated large seismic forces on the lower structure and severely damaged it. St. Blaise and Benedict Church in Novo Selo Glinsko suffered extensive damage and its bell tower collapsed (Figure 26b). Causes of this damage and direction of fall of the bell tower are analogous to those previously mentioned for family houses in this village. Some additional disadvantages for this church should be mentioned, i.e., its elevated location (higher seismic forces) and inappropriate wooden, concrete and masonry structure.

Figure 26. Some of the churches heavily damaged in the earthquake: a) St. Mary Magdalene Church in Sela; b) SS. Blaise and Benedict Church in Novo Selo Glinsko; c) Church of the Assumption of the Blessed Virgin Mary in Gora

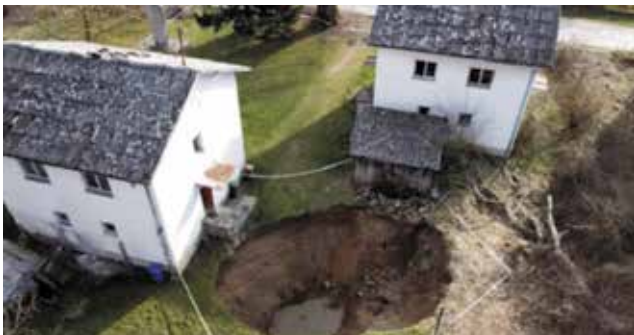
Soil liquefaction generated during this earthquake greatly influenced formation of over a hundred sinkholes in soil within the narrower epicentral area of the earthquake, mostly in the village of Mečečani located about 22 km SE of the epicentre. They are large, reaching up to 15 m in diameter and depth, and some have appeared next to houses (Figure 27). Their formation is due to soil displacement (vibration) caused by earthquake in areas of intensely saturated water in the drainage basin of nearby rivers and their tributaries, where deep layers of loose sandy soil are likely to be found under a thin layer of humus. In fact, over time, and especially during an earthquake impact, loose soil is lowered and compacted, and the

surface layer is deeply deteriorated due to exceedance of its very low shear strength at the failure plane. Sinkholes, as expected, are approximately circular in plan and almost vertical. The formation of sinkholes is probably greatly influenced by the change in the level of water in soil, and its vertical and horizontal movement, which leads to washout and removal of small sand particles and to deterioration of larger and heavier soil particles.

Figure 27. One of many sinkholes in Mečečani [16]
