Fatigue characterisation of concrete composite girder with steel bottom plate and corrugated web under uniform corrosion environment

Research Paper

Genhui Wang, Pulu Han, Xuejun Jin

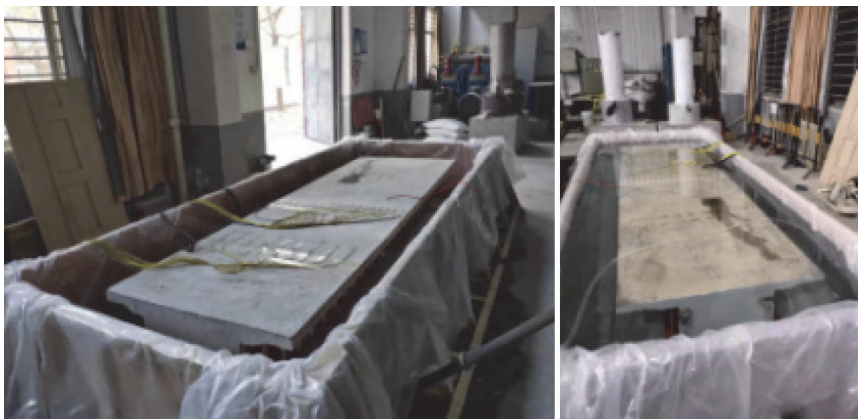
Figure 4. Girder corrosion test setup

In a corrosive environment, the girder is generally surrounded by corrosive air, which is equivalent to immersion. To accelerate the test process, a salt corrosion test was conducted using a long-term immersion method, in which the girders were fully immersed.

The girder was formed by combining steel and concrete, and long-term immersion tests can be accelerated by increasing the solution’s concentration. Hence, the concentration of NaCl solution was chosen to be 6% for this test. As depicted in Figure 4, one of the test girders was immersed in the NaCl solution and designated as girder #2, whereas, the unimmersed test girder was designated as girder #1.

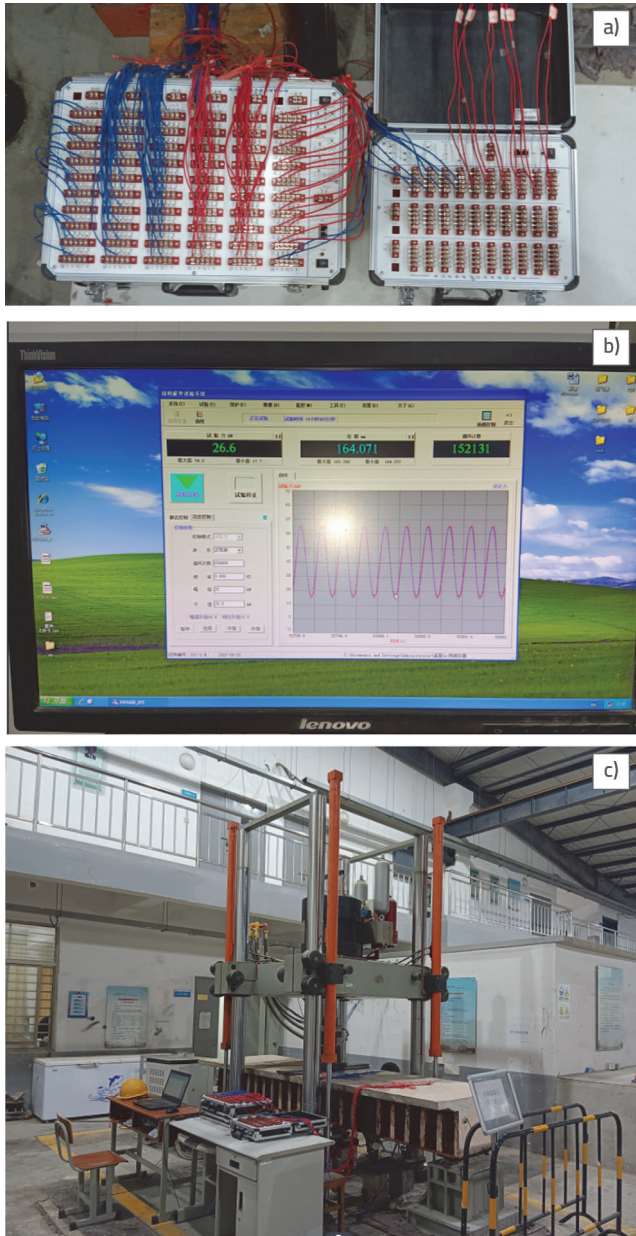
Figure 5. Girder fatigue test: a) Stress-strain sampling system, b) Fatigue loading system, c) Test girder loading

Table 1 lists the loading conditions and Figure 5 shows the fatigue loads. Static loading was followed by each level of the fatigue-loading cycle, which had a maximum load of 80 kN. Test data were collected at every 10 kN after static loading.

Both the test girders underwent fatigue and static tests under the same load rating. Two types of fatigue loading tests were reported [22], which include the fatigue characteristic test and fatigue failure test. Sinusoidal fatigue loads were utilised, and the load frequency was determined to be 3 Hz. The fatigue load calculation model from [21] was used to calculate the fatigue loads of the original bridge. Using the constant load stress value as the lower limit for loading the composite girder model, the stress value when working with constant load was assumed and the live load on the girder model was considered as the upper limit value. For 2 million cycles, the fatigue test load was subjected to loads with upper and lower limits of 53.5 and 16.5 kN, respectively. The fatigue failure test exhibited an increase in load amplitude and a graded result.

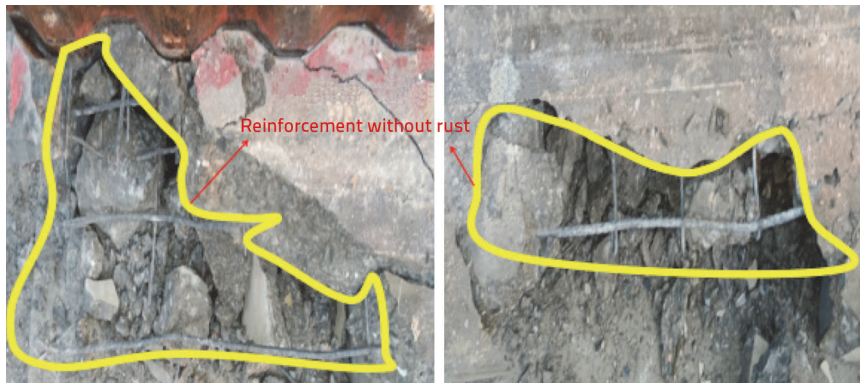
Figure 10. Corrosion of steel bars

Because of the concrete protection, no corrosion occurred on the reinforcement in the top slab. As shown in Figure 10, the chloride ions can be ignored in the top plate of the composite girder.

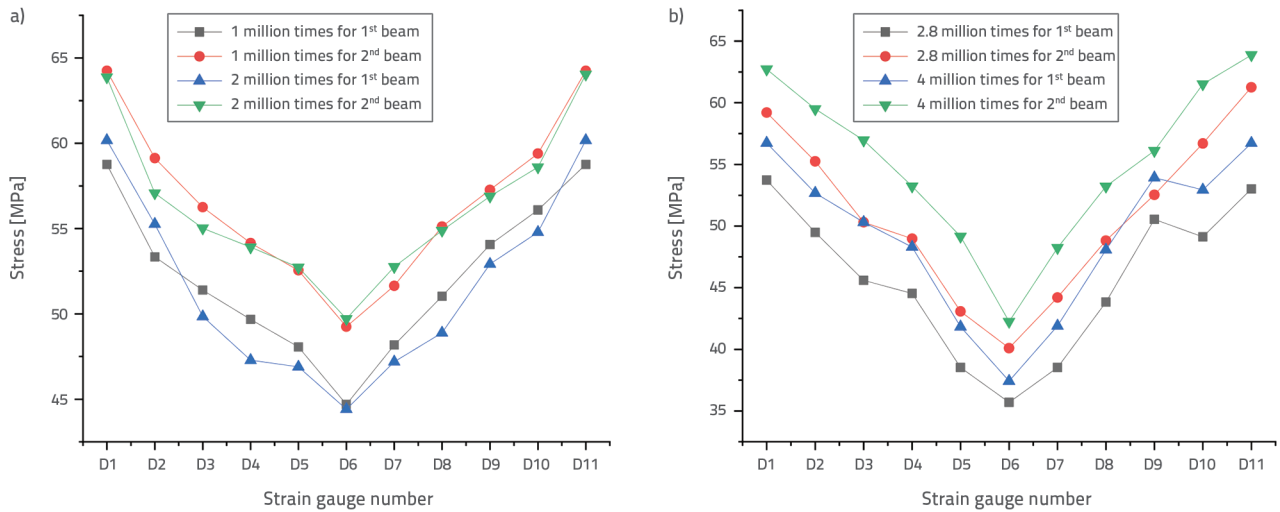
Figure 12. Bottom plate stress: a) Fatigue characteristic test stress; b) Fatigue failure test stress

At 80 kN, stress results were obtained using the adopted static test values. As an example of the results after 1 and 2 million cycles of fatigue loading, the stress values of the fatigue characterisation test are presented. As an example of the results after the aforementioned load cycles under 49 and 72 kN of fatigue loading, the stress values of the fatigue failure test are presented. These are illustrated in Figure 12.

As shown in Figure 14, Test girder #1 exhibited a lower stress level than test girder #2. After the corrosion, the stress levels increased by approximately 10%. Combining this result with the stress calculation formula for a three-point loaded girder

would allow the calculation of parameters, such as the girder corrosion rate. As shown in Figure 14.a, after 1 and 2 million fatigue tests, the stress values of the two test girders were relatively similar. Corrosion reduced the effective bearing area of the test girders, whereas fatigue loading did not. As demonstrated in Figure 10.b: after the median load was applied after the number of load cycles under 49 and 72 kN fatigue loadings, the two test girders showed significant differences in their respective stress values. This indicated that the effective bearing area of the test girder decreased during the fatigue failure test. Calculations were necessary to determine the exact number of cycles that occurred.
