# Pozzolanic mortars for the conservation of old masonry structures

Professional paper

### 1.1. The Bač Fortress – values and history of conservation efforts

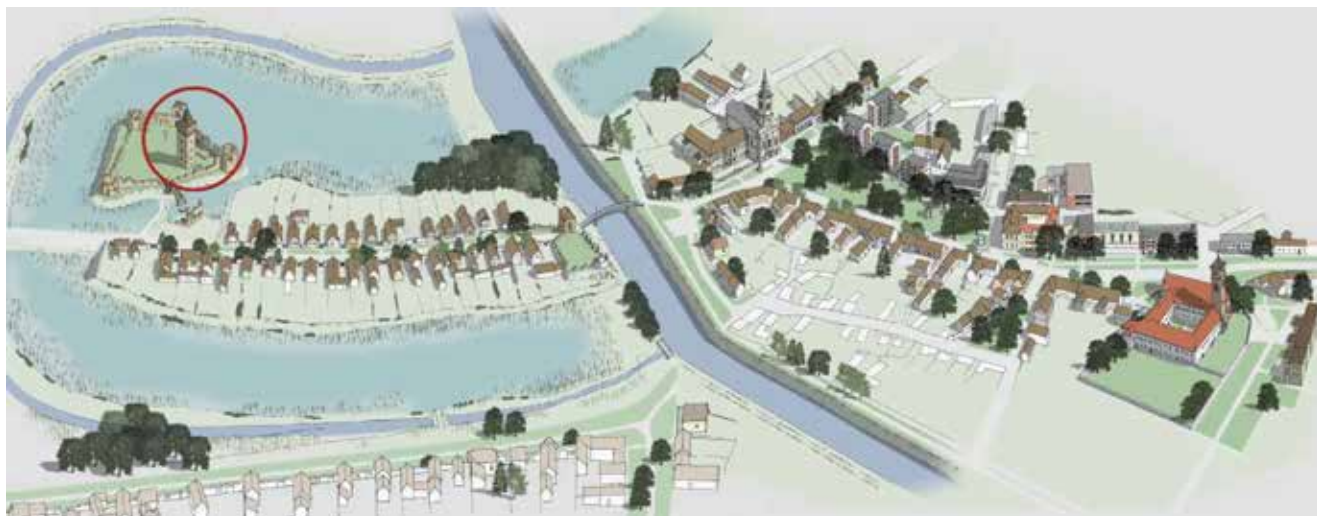
Figure 1. Panoramic view of Bač with the fortress at the left side and the Dungeon Tower marked with a circle [2]

The Bač Fortress is classified as a *fortress on water*, with the defence system adapted to marshy land. It consists of a fortified castle and suburb located on a meander of the river Mostonga (the Danube tributary). The fortified complex is situated in the vicinity of the town of Bač, on its west side, Figure 1. The place where the fortress is located is a significant archaeological site populated uninterruptedly since the late Neolithic period. The first building phase dates back to the period between 1338 -1342, and the Hungarian King Charles Robert of Anjou. Intensive building activities started in the mid 15<sup>th</sup> century, when new warfare techniques were adopted, and the southern boundary was strengthened against Turkish incursions. However, the Turks did conquer the fortress in 1529, and they used it until the year of liberation, 1686. During the Rakoczy uprising (1704), the fortress was devastated, never to be restored again. Although its physical integrity has substantially been lost, the preserved elements point to a sophisticated architecture of the fortification school of High Gothic style, with some elements of the early Italian Renaissance.

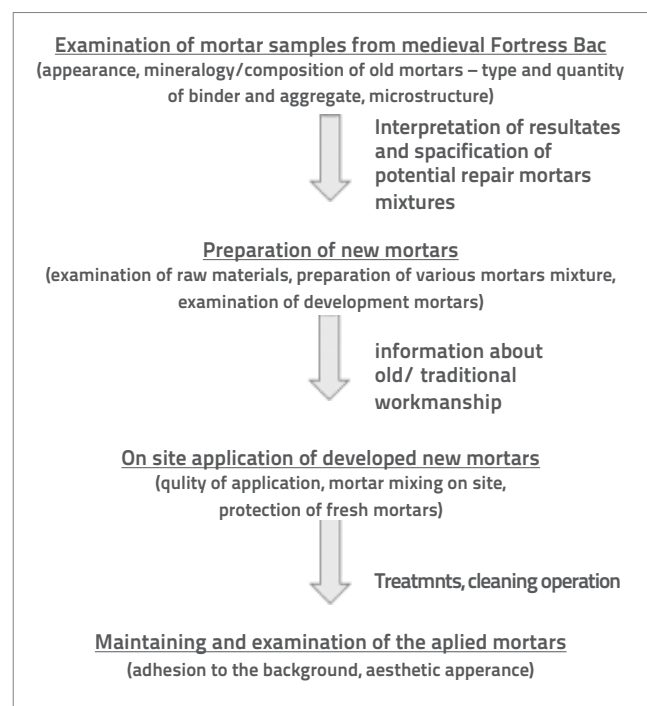
Figure 3. Schematic view of methodology adopted for newly developed mortars

In order to obtain results that could lead to a qualitative development of newly designed mortars, the investigation work was concentrated on four aspects: laboratory investigation of old mortars from floors of the Dungeon Tower, development of new mortars in laboratory conditions, *in situ* application of developed mortars with a sustainable conservation procedure, and examination of the applied mortars after a determined period of time (4 years), Figure 3. This methodology was set up by a multidisciplinary research team consisting of archaeologists, architects and civil engineers from the Regional Institute for Protection of Cultural Monuments, Petrovaradin, and researchers specializing in the materials science and microbiology from the Faculty of Technology, University of Novi Sad.

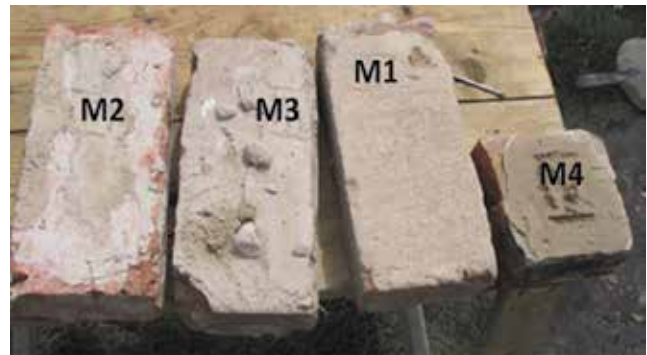
Figure 8. Testing workability and consistency of prepared mortars

Besides chemical, esthetical, physical or mechanical characterization that is generally made in the case of the newly developed materials, the conservators are also concerned about workability aspects [13]. The workability of a chemically compatible mortar can not be guaranteed in advance. Therefore, one or more application tests are often decided upon on site. Some in situ tests were performed to study workability and consistency of prepared mortars (Table 6). Prepared mortar samples were placed on glass plates in form of a truncated cone (cookies of about 9 cm in diameter) by manual vibration in order to assess volume consistency [14]. These steps were significant for defining aesthetic, adhesive, and mechanical properties of the newly designed samples M2, M3 and M4, which were to be used as finishing floor mortars. The mortar sample (M1) with the binder/aggregate ratio 1/5 was planned to be a base mortar that would be used together with M2-M4 finishing mortar samples. Some observations considering the differences between the applied mortars M2-M4 were made after 24 hours of drying in the shade, Figure 8. In the case of the mortar sample M2 the surface was cracked and rough with spots. The mortar sample M3 also had a rough

surface, but of a lesser intensity and with fewer crumbles. The last sample, the mortar sample M4, did not have visible cracks, and the surface was smooth as an adequate plasticity with the desired tonal effect was achieved.

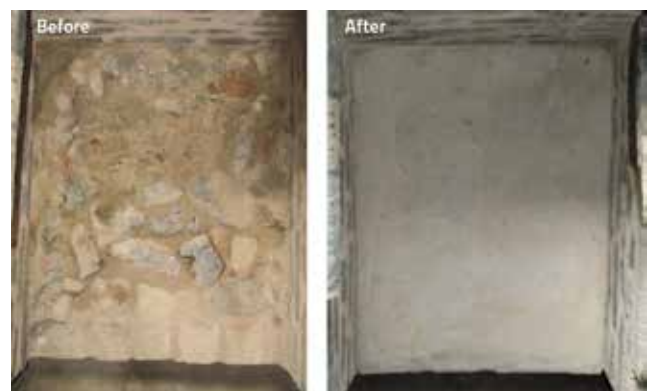
Figure 9. Appearance of the floor area before and after conservation treatment [4]

Taking into consideration laboratory results and results obtained by in situ testing of mortar samples, the M4 sample was finally selected for the conservation treatment of the Dungeon Tower floor area. This mortar satisfied numerous required properties such as: good hardening time and adhesion properties, good aesthetic appearance (colour, texture, surface finish), similarity to the authentic finishing mortar, and good workability without any cracks during the hardening process. After the mortar production and selection, the conservation treatment of the floor was performed. The following procedures were applied: the joints were carefully cleaned (by washing with water, and by removal of all loose parts of the bricks and mortars) and the base mortar M4 was applied, Figure 9.

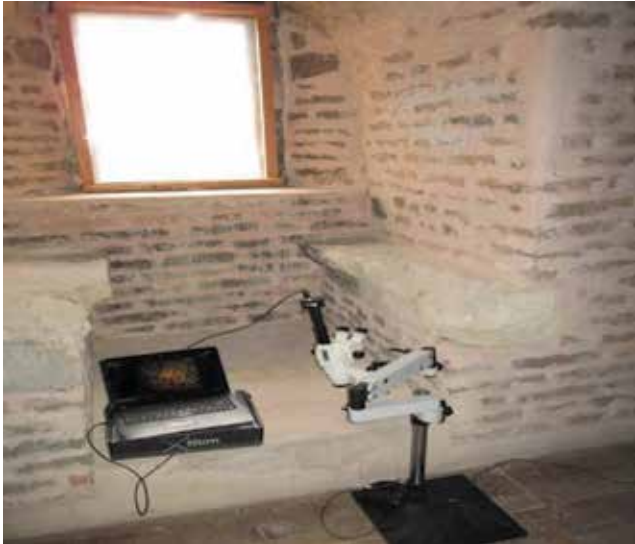
Figure 10. In situ investigation with a stereo-optical microscope

The behaviour of the applied mortar M4 in real environmental conditions was monitored four years after the application. The treated area in the Donjon Tower was inspected in situ

using a stereo-optical microscope, Figure 10. This kind of investigation is a suitable method for the detection of cracks or micro cracks that directly determine the durability and aesthetic performance of the applied mortar. The results are shown in Figure 11.
